A Possible Solution to Tip Stalling in Swept 'Wings

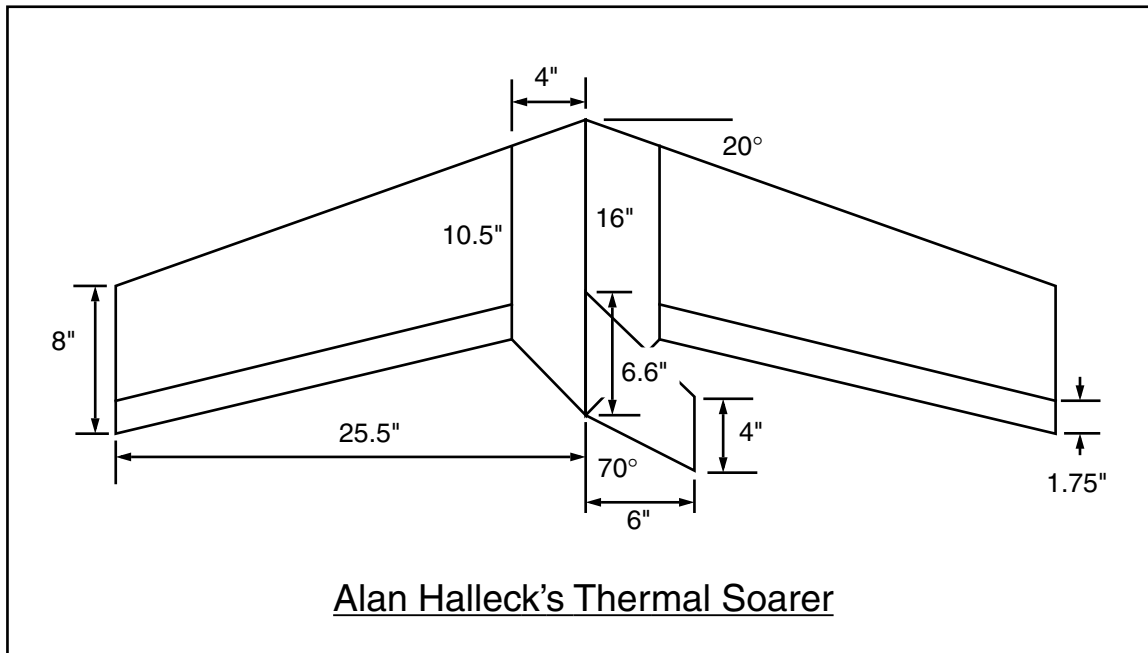
At the thermal field, the foreshortened wing, when banked for a tight thermal turn, tip stalled viciously, taking nearly a full turn and a lot of altitude to recover. Alan's 'phone call to us, while not an act of desperation, was clearly highly motivated. Alan covered the relevant points: the tip chord, due to the shortened span, was broader than originally anticipated for the design; straight and level flight posed no problems, so pitch stability was sufficient; the CG was in the correct position.

Since no solutions immediately came to mind, the conversation drifted to other topics. Alan started talking about his computer radio and all of the exciting things it could do, like mixing differential into and between various control surfaces. This got our attention! It turned out Alan had put nearly 2:1 differential in the aileron function of the transmitter. After some discussion, it was decided the differential was most likely the problem, and Alan decided he would try flying his creation with all of the differential removed.

Removal of all aileron differential completely eliminated the tip stalling problem, and turned an otherwise nasty airplane into a relatively docile flyer. Alan has since flown the 'wing successfully both at the slope during light lift conditions and in a thermal environment.
