THE FLETTNER FLAP

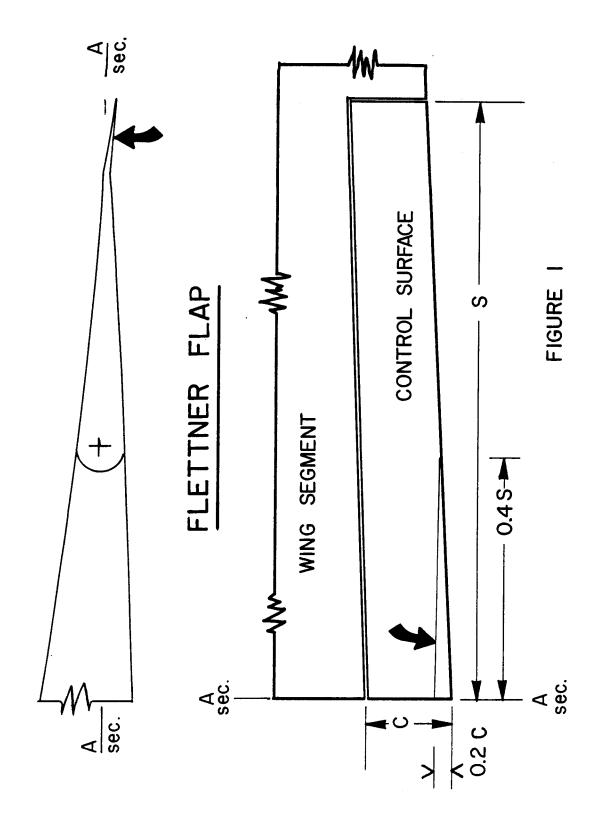
The Flettner flap is a simple mechanical device which reduces the down load on the control surface by acting as an aerodynamic balance. The size of the Flettner flap should be directly related to the size of the control surface; see the diagram on the next page.

As you can see, the flap is not large. Its effect on overall drag is probably negligible. An additional bonus - it can usually be installed as a retrofit on an existing design.
