## 1/4 Scale Pioneer II-D at 60 Acres

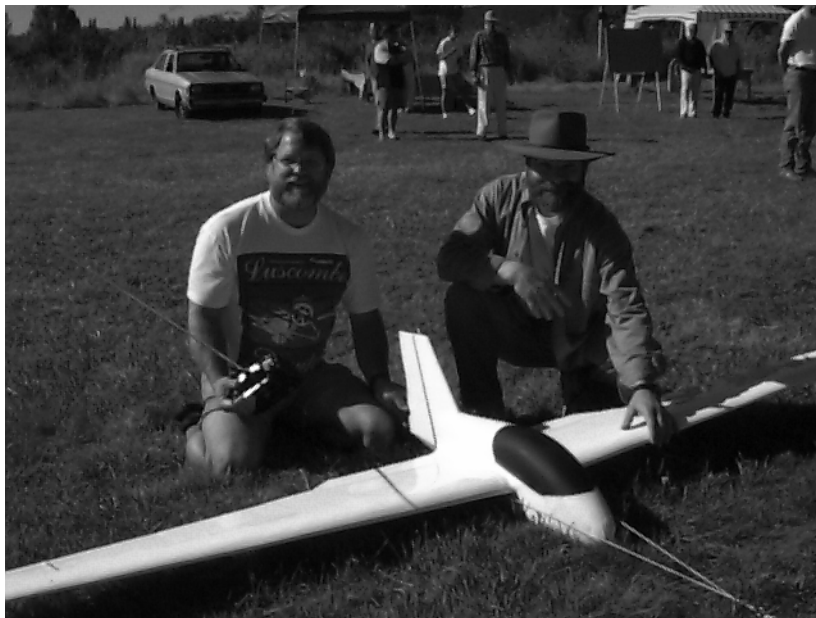
Don Bailey, Bill, and the Pioneer II-D at 60 Acres

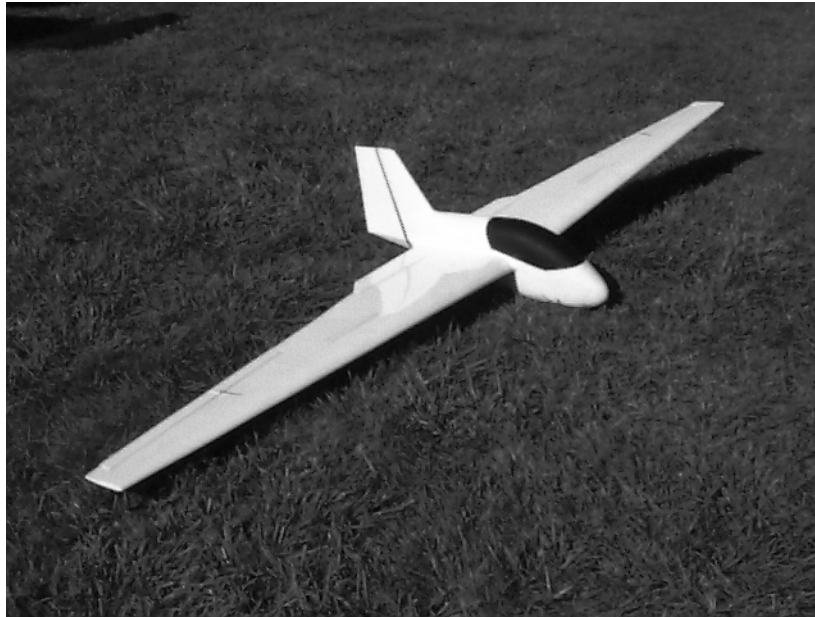
At 60 Acres in August, we got a chance to see first hand the change which had been imparted. Don had replaced the releasable tow hooks with more standard fare and constructed a bridle which snapped onto the end of the winch line. A large battery pack reduced the necessary lead in the nose to a minimum. Now all white, the Pioneer looked just like its full size counterparts.
